White River Watershed Assessment

Third Branch Stream Classification and Erosion and Sediment Inventory

February 2001

Natural Resources Conservation Service

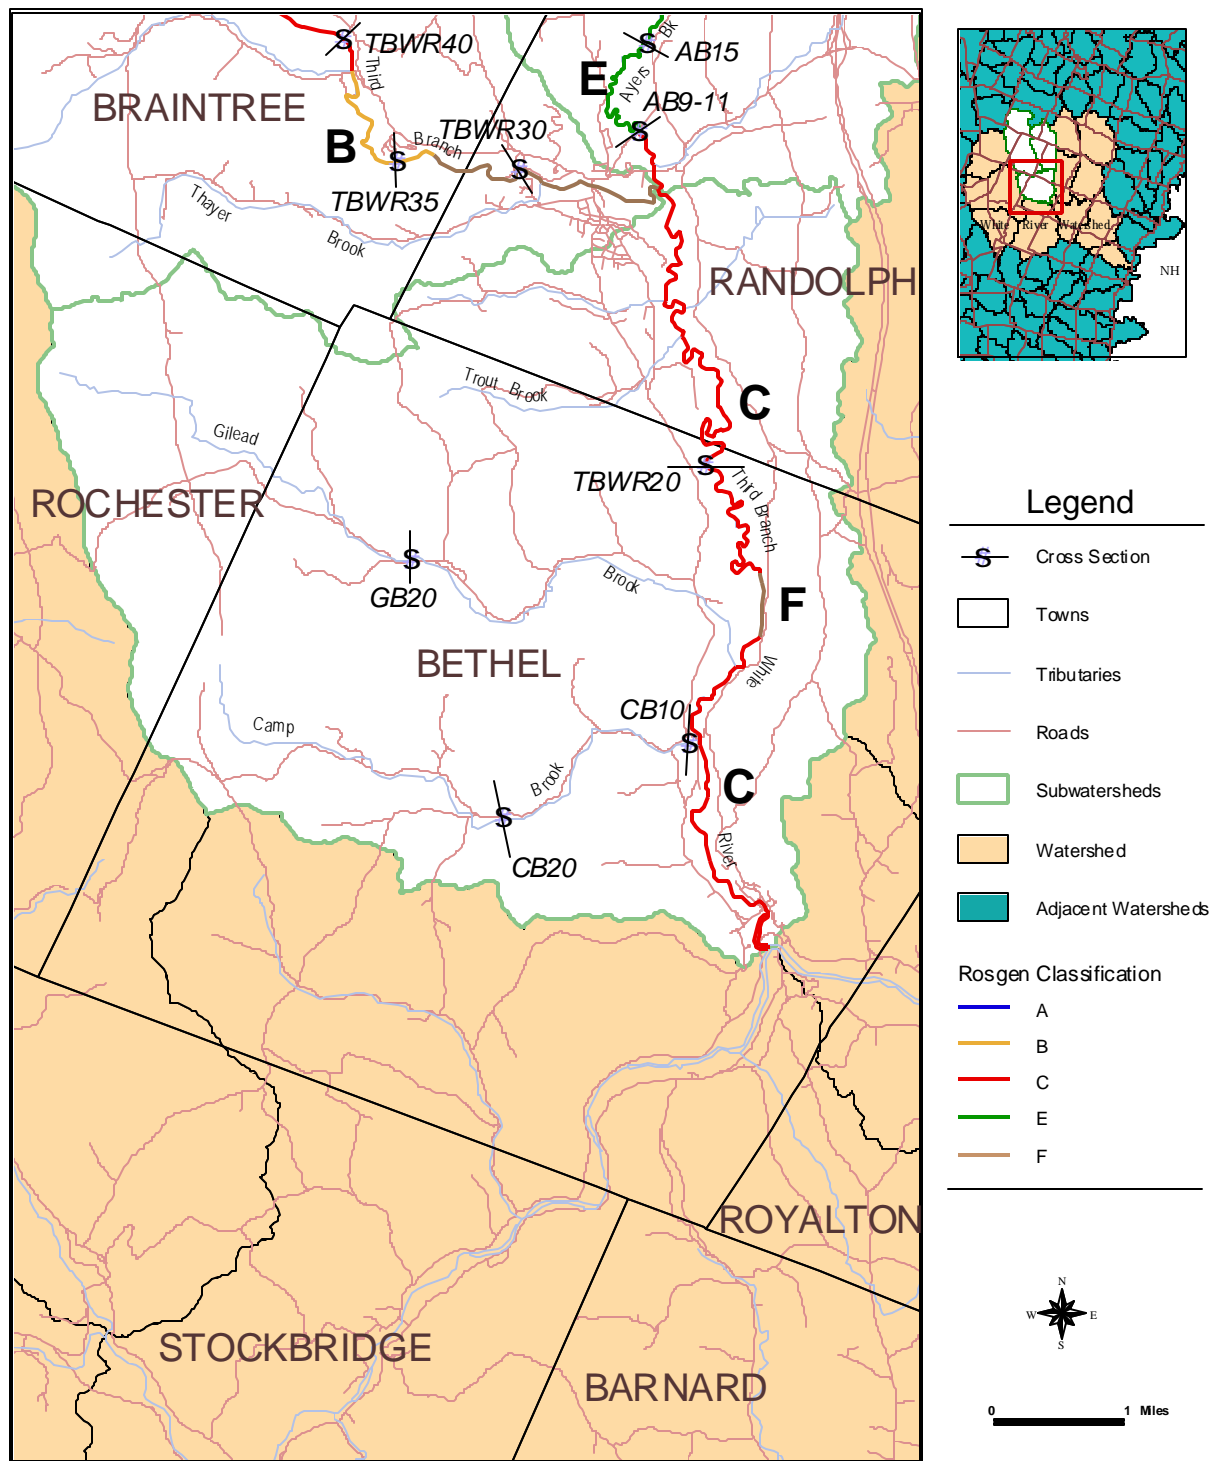
Figure 8 - Third Branch Cross Sections Downstream of Randolph

The Third Branch was observed at three different locations in a 4-mile reach downstream of Randolph. A cross section survey was performed at one of these locations (See Figure 8 - Third Branch Cross Sections Downstream of Randolph). Cross sections done on Camp and Gilead Brooks are also shown on this figure. The remaining 5.5 miles of the Third Branch were not observed during the field work. The river appears to be a degraded C4 stream type in Stage III of the Channel Evolution Model (CEM). The active bank erosion in this reach may be due to the river continuing

to adjust its cross-section dimensions and plan form since gravel mining was curtailed in 1986. However, the riparian corridor vegetation is also in poor condition so the banks have little erosion resistance. The accelerated bank erosion may be due to one or both of these two probable causes. The Vermont Stream Alteration Engineer did comment that the banks in this reach appear to be eroding at a reduced rate from 10 years ago when the gravel mining was still occurring.

There are high, 8 feet or greater, eroding banks at a number of locations in the Third Branch reach downstream of Randolph. These high banks occur as the river migrates across the valley floor and encounters the valley walls consisting of glacial terraces. It does not appear that the high banks are due to downcutting in the Third Branch. However, the presence of the high banks and the accelerated rate of bank erosion indicate this reach is probably producing the greatest amount of sediment to the White River compared to all the reaches observed in the field the week of June 15, 1998. This reach was turbid the week of June 15, following a large rainfall event.

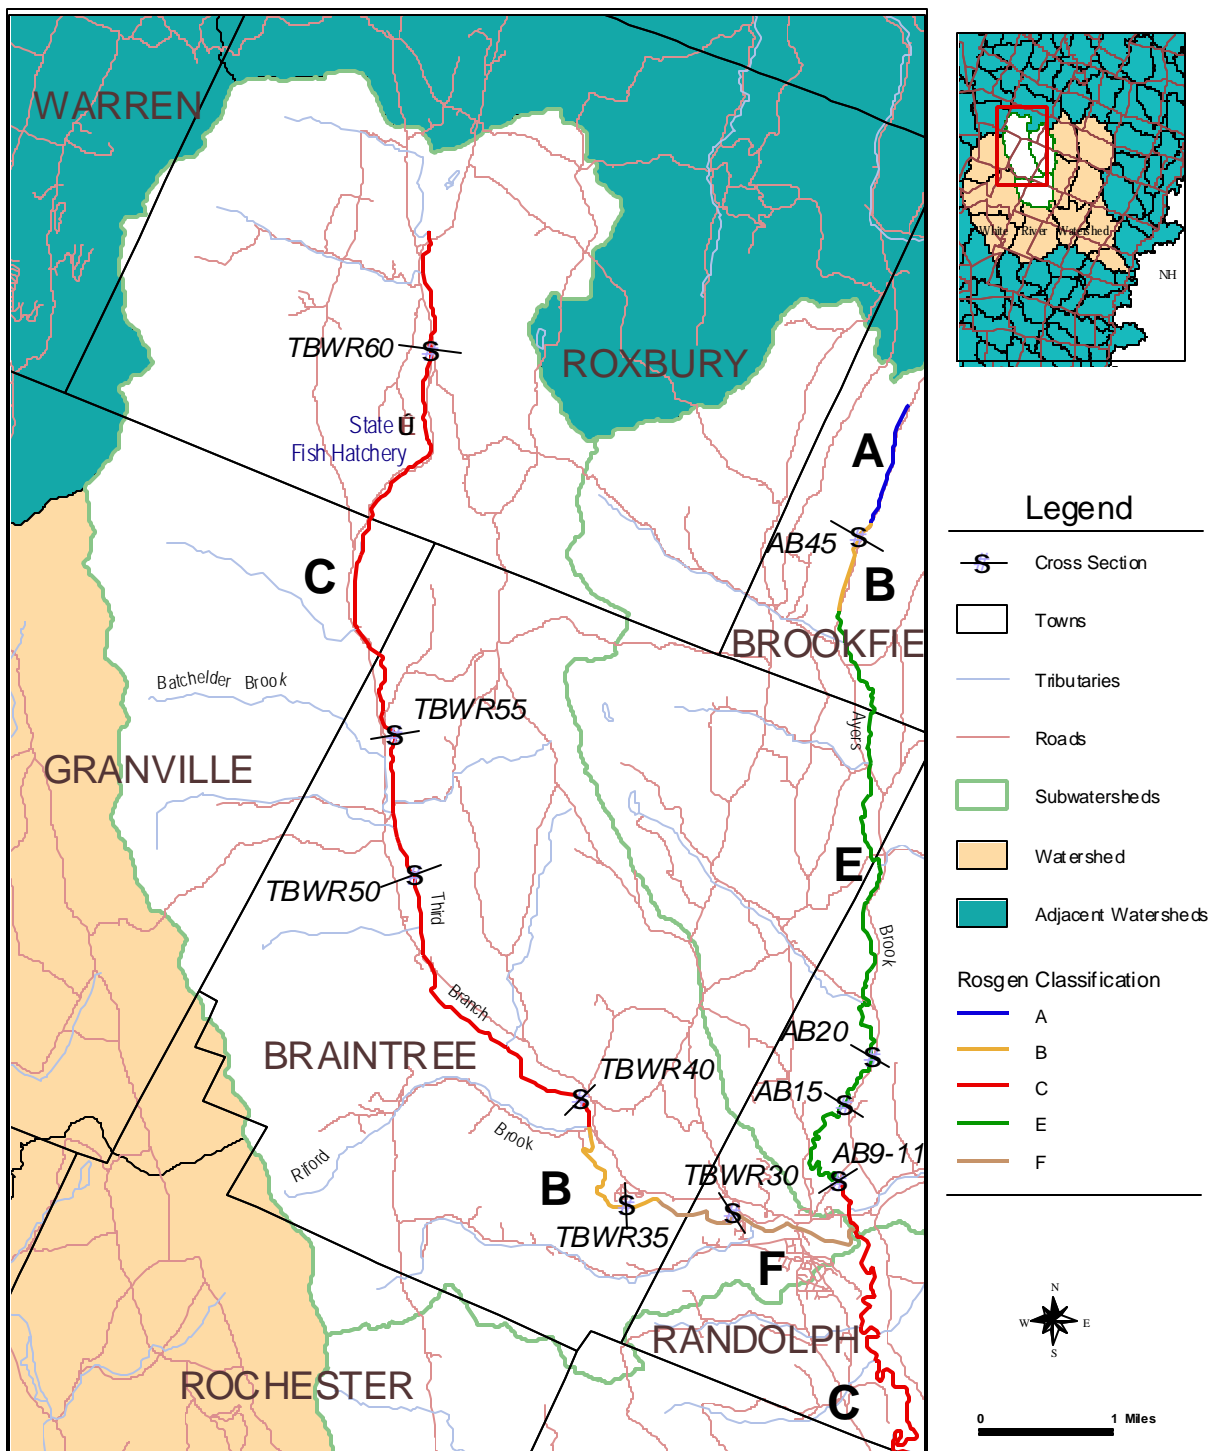
Figure 9 - Third Branch Cross Sections Upstream of Randolph

The Third Branch upstream of Randolph was observed, and cross section surveys performed, at six different locations (See Figure 9 - Third Branch Cross Sections Upstream of Randolph). The river appears to be a C3/C4 river in fairly stable condition except where the cross section was modified by pushing gravel and cobbles out of the bed of the river and up onto the banks and the floodplain after the floods of 1973 and 1976. Where the gravel and cobble “windrows” became stabilized by woody vegetation, the river appears to take on the characteristics of a B3/B4 stream type (moderately confined) as seen at the commercial campground just upstream of Randolph. The gravel windrows may have extended from the town park in Randolph to just below the confluence of Riford Brook and the Third Branch. The river just upstream of the park and upstream of Riford Brook appears to be a C3/C4. The river adjacent to the gravel pit south of the river downstream from Riford Brook appeared to be similar to the river at the campground (B3/B4).

The river between Riford Brook and Batchelder Brook, the next location observed, is a C3/C4. Just upstream of Batchelder Brook, the river may be more similar to a B or F stream type due to the encroachment of the highway and the railroad in that narrow valley floor reach.

The last location observed on the Third Branch was just below the State Fish Hatchery near Roxbury. The river was classified as a C3/C4, but it appeared somewhat degraded. The active bank erosion appeared to be due to the poor condition of the riparian corridor vegetation as opposed to a channel adjustment process. The banks are low in height, so the stage of channel evolution for this reach was either Stage I or Stage III.

The river was not observed between the railroad crossing above Batchelder Creek and the last point surveyed. It appeared the river had been moved up against one side of the valley floor or the other throughout this reach to facilitate access to the valley floor for farming and to keep the river away from the road and railroad. Linear wetlands, some with beaver dams, were evidence of old channel remnants prior to channel

realignment. It is assumed the river has evolved to a C3/C4 similar to the reaches observed upstream and downstream of this reach. However, the channel modifications may have resulted in disconnecting the river from its active floodplain. In those situations, the Third Branch may be an F or B stream type.

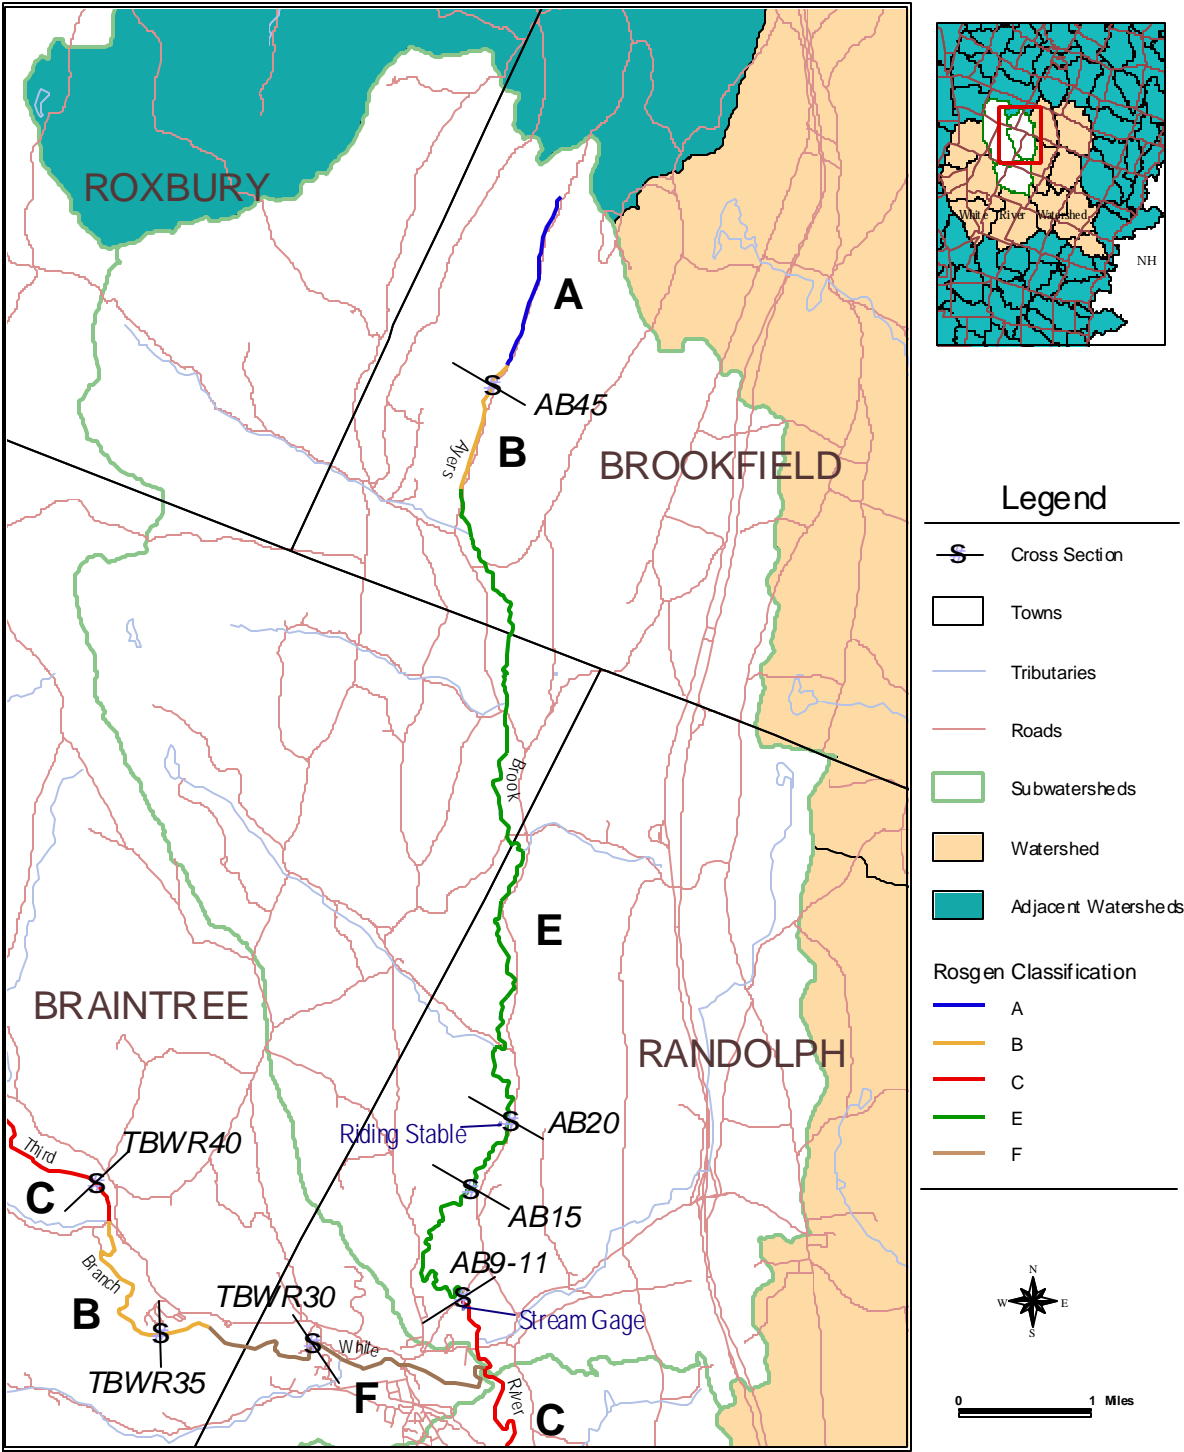
Figure 10 - Ayers Brook Cross Sections

The active floodplain adjacent to the stream became wider further upstream. The channel became unconfined at about one mile upstream of the gage, and it was classified as an E4/E5 stream with a W/D ratio of 10 (39.7 feet/ 3.9 feet). An E stream type in good condition usually has a much lower W/D ratio than 12. It appears that the poor condition of the riparian vegetation was allowing accelerated streambank erosion resulting in a wider stream. The stream width in this reach was similar to the 40-foot width near the gage. Even though the stream was classified as an E, it is probably an E degrading into a C.

The channel was observed at a point about 5 miles upstream of the gage, but no measurements were taken. There were no glacial lake sediments or other terraces in this reach, and the active floodplain was almost a half-mile wide. Active bank erosion

was occurring in this reach. The erosion appeared to be due to the poor condition of the riparian corridor vegetation as opposed to a channel adjustment process.

The next upstream cross section was on a reach of stream that had an active floodplain between it and the road. This unconfined stream had a W/D ratio of 13 and a slope of about 3%. This reach was classified as a Cb3/b4; a steep C stream type. It appears to be stable and may be a transition between the steeper A and B types upstream and the E channel further downstream.

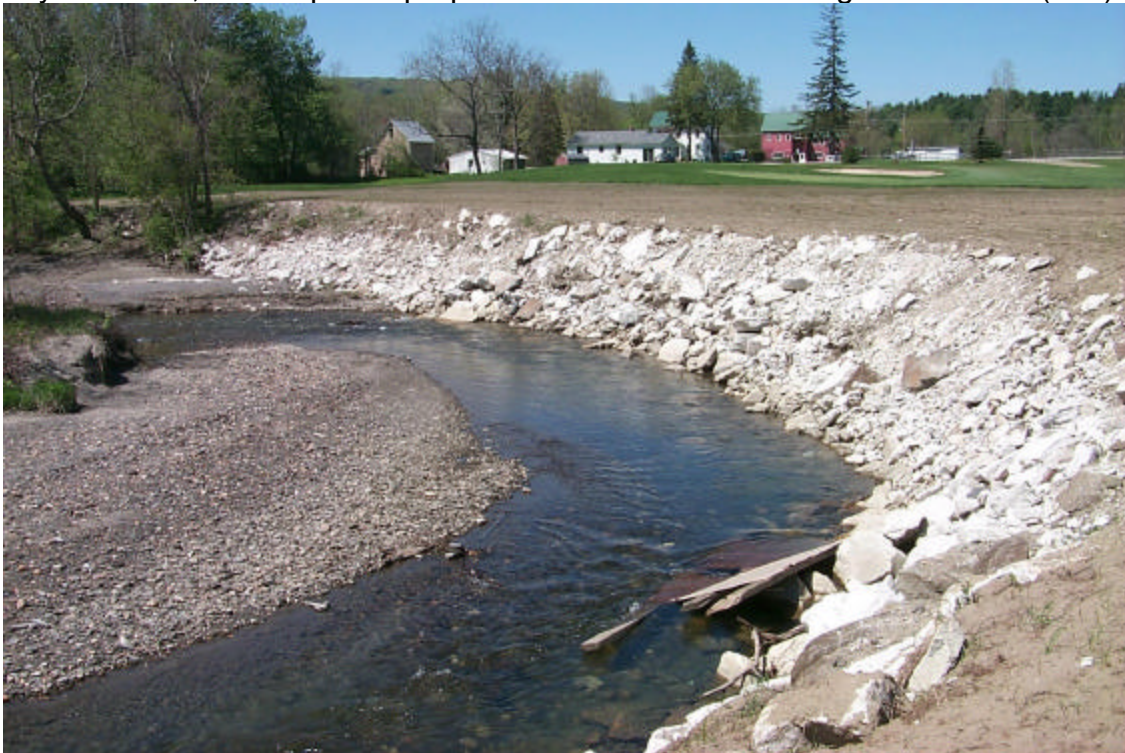
Figure A1

Ayers Brook, Randolph - Riprap Bank Protection at Montague Golf Club (#64)

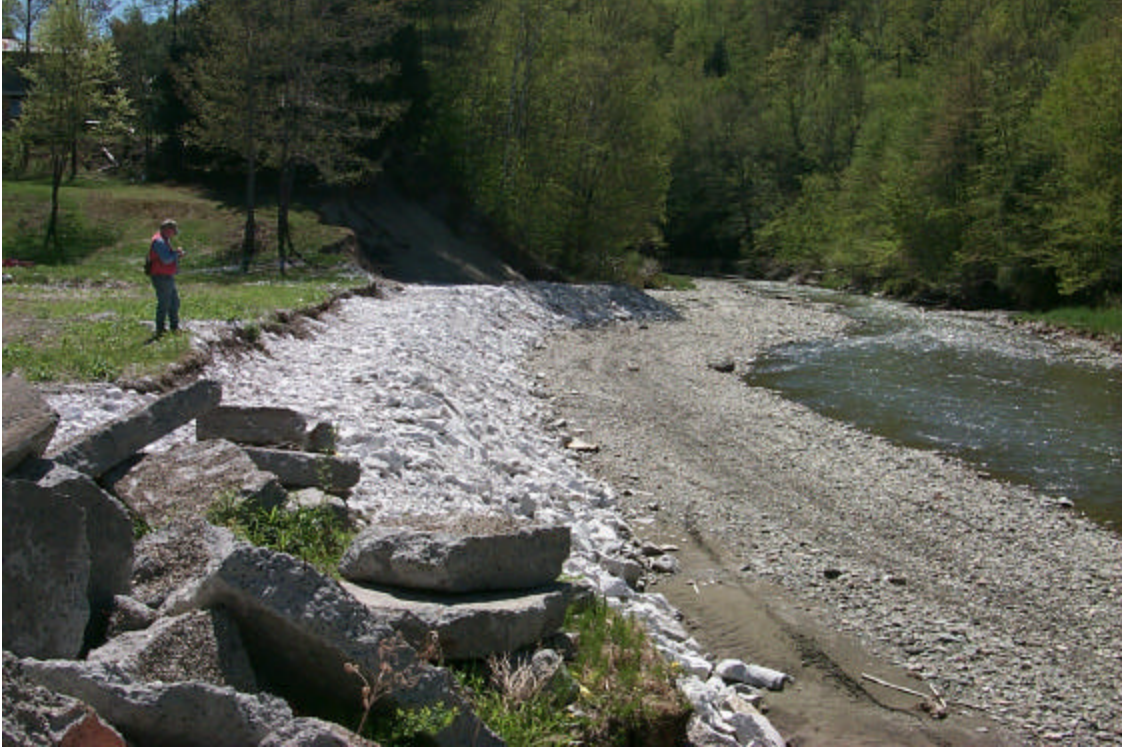
Figure A2

Third Branch, Braintree - Residential Riprap Site (#77)

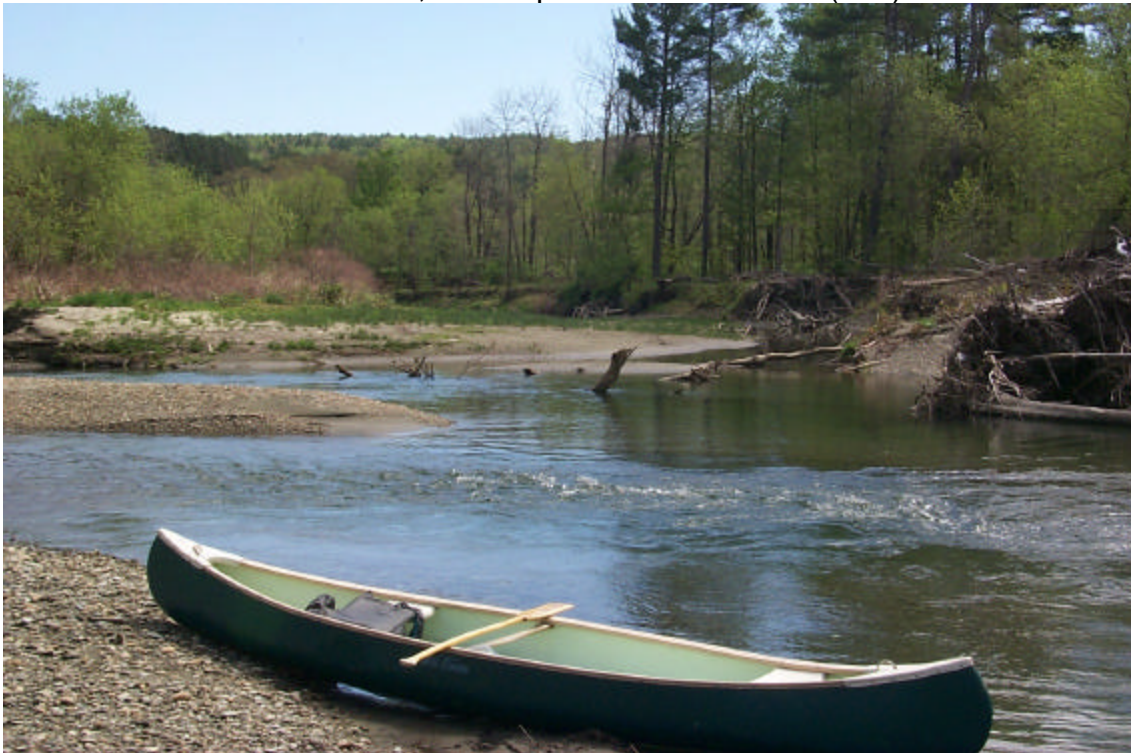
Figure A3

Third Branch, Randolph - Meander Cutoff (#13)

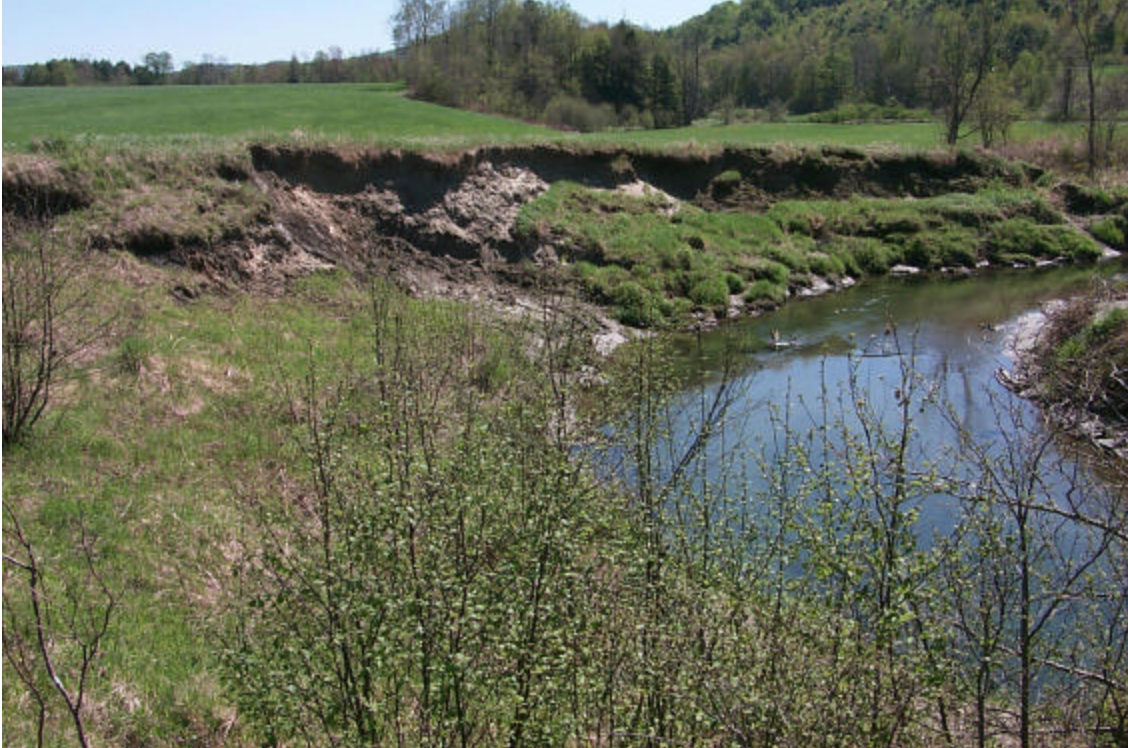
Figure A4

Ayers Brook, Randolph - Streambank Erosion, Agricultural Area (#67)

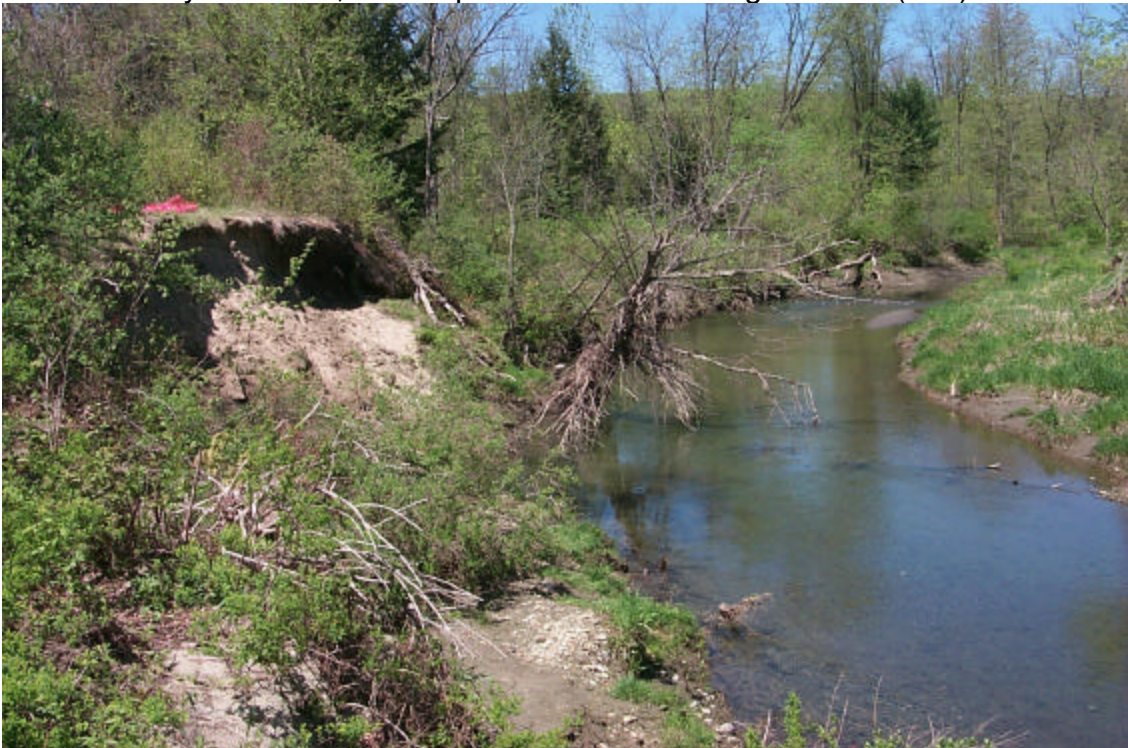
Figure A5

Ayers Brook, Randolph - Erosion Near High School (#59)

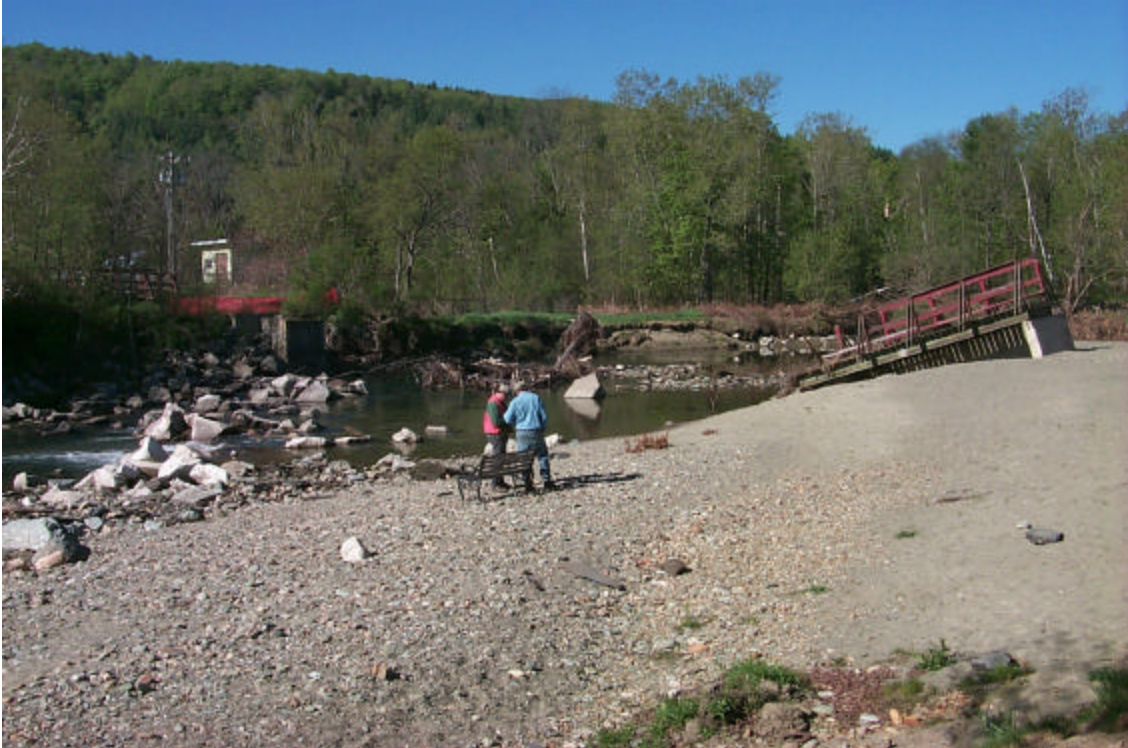
Figure A6

Third Branch, Randolph - Flood/Erosion Destroys Park Footbridge (#70)

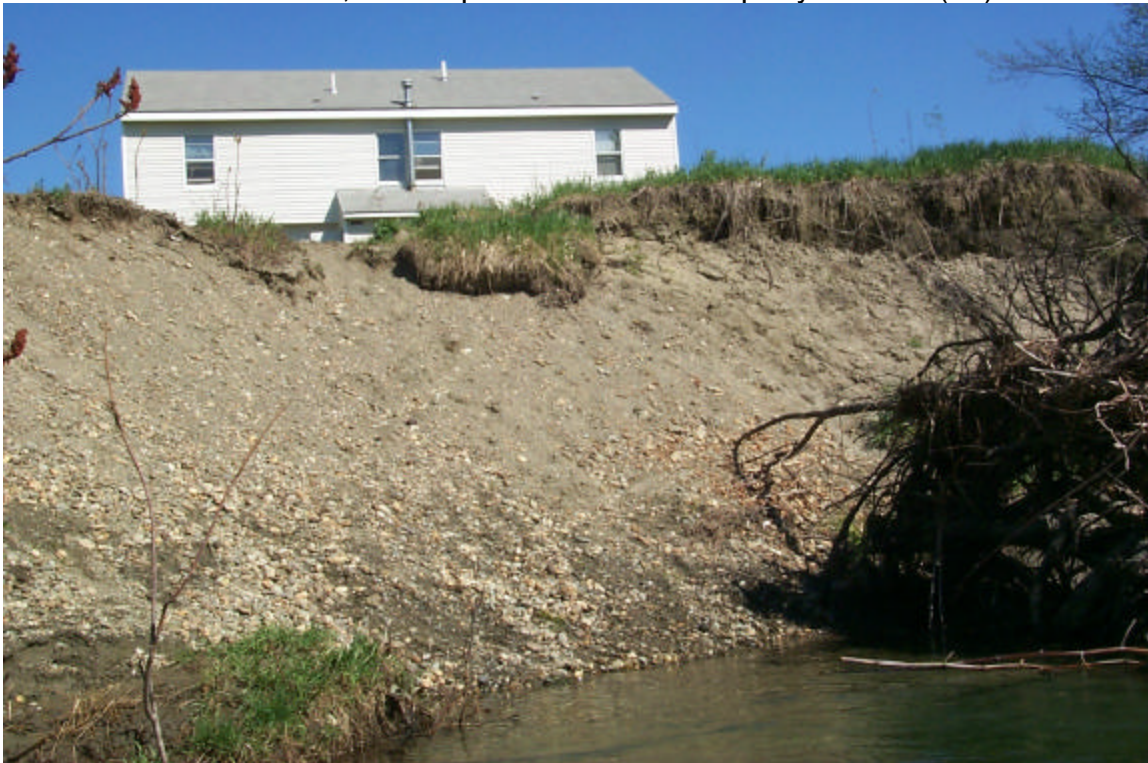
Figure A7

Third Branch, Randolph - Residential Property Erosion (#3)

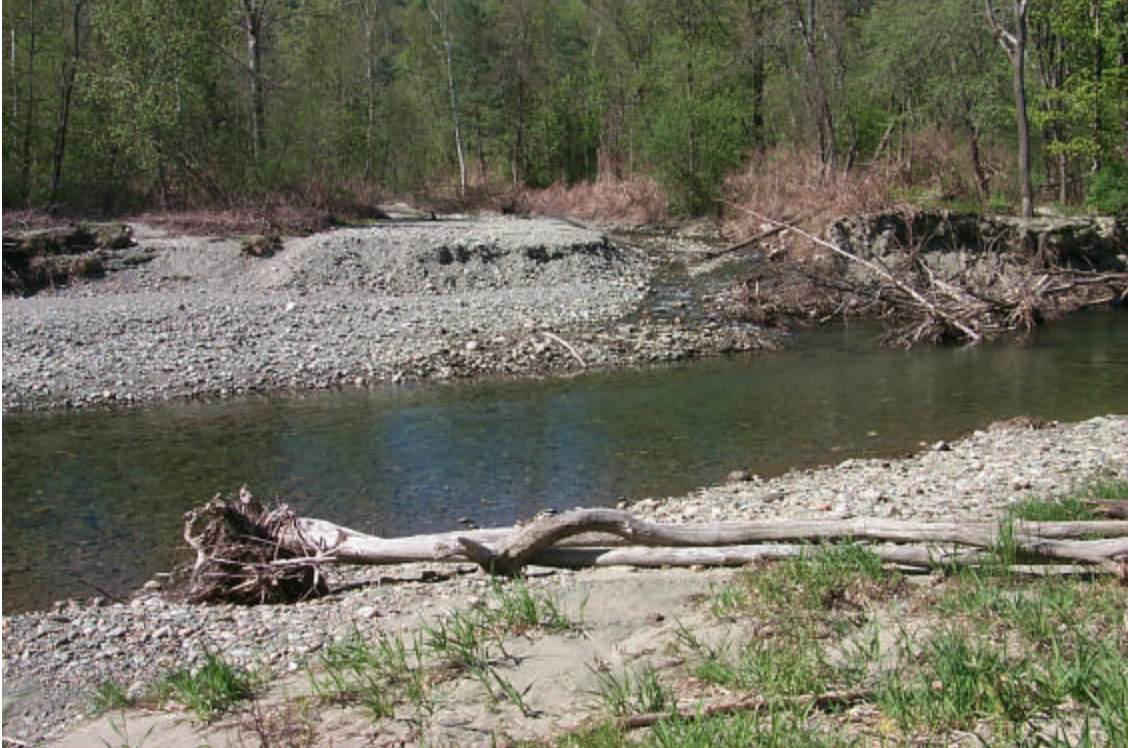
Figure A8

Third Branch, Randolph - Sediment Deposits at Thayer Brook Tributary (#74)

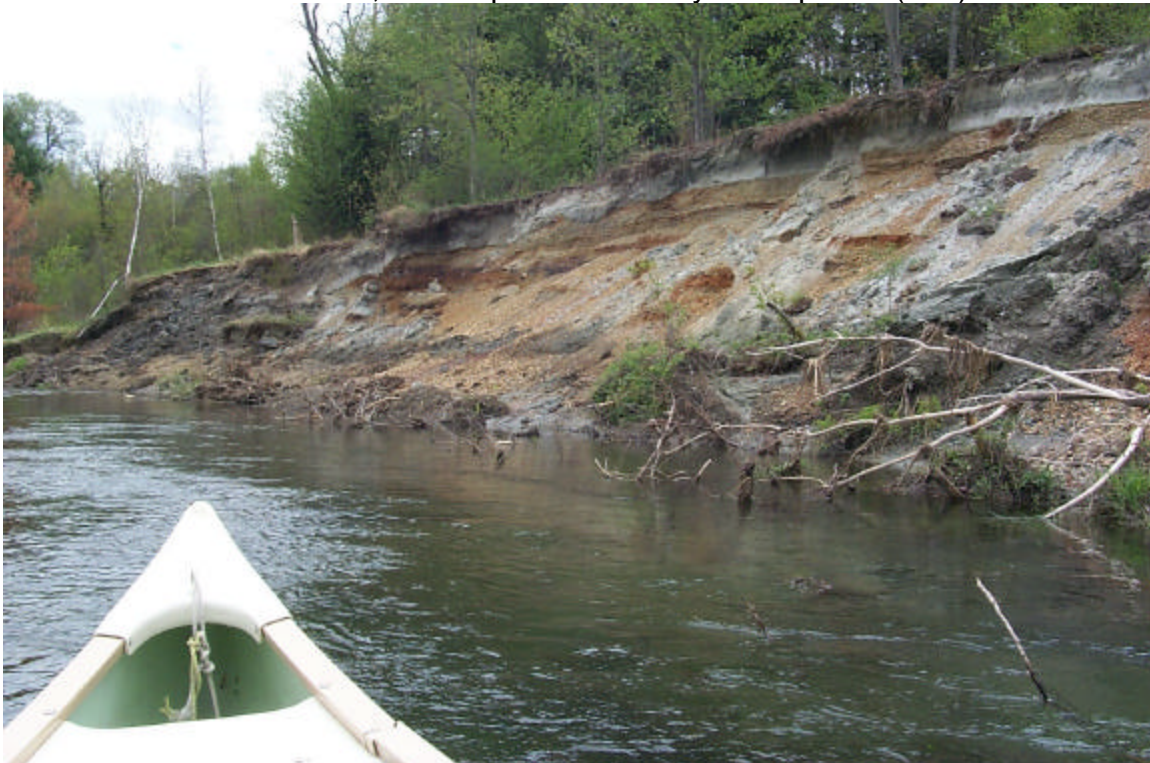
Figure A9

Third Branch, Randolph - Gravel Layers Exposed (#25)

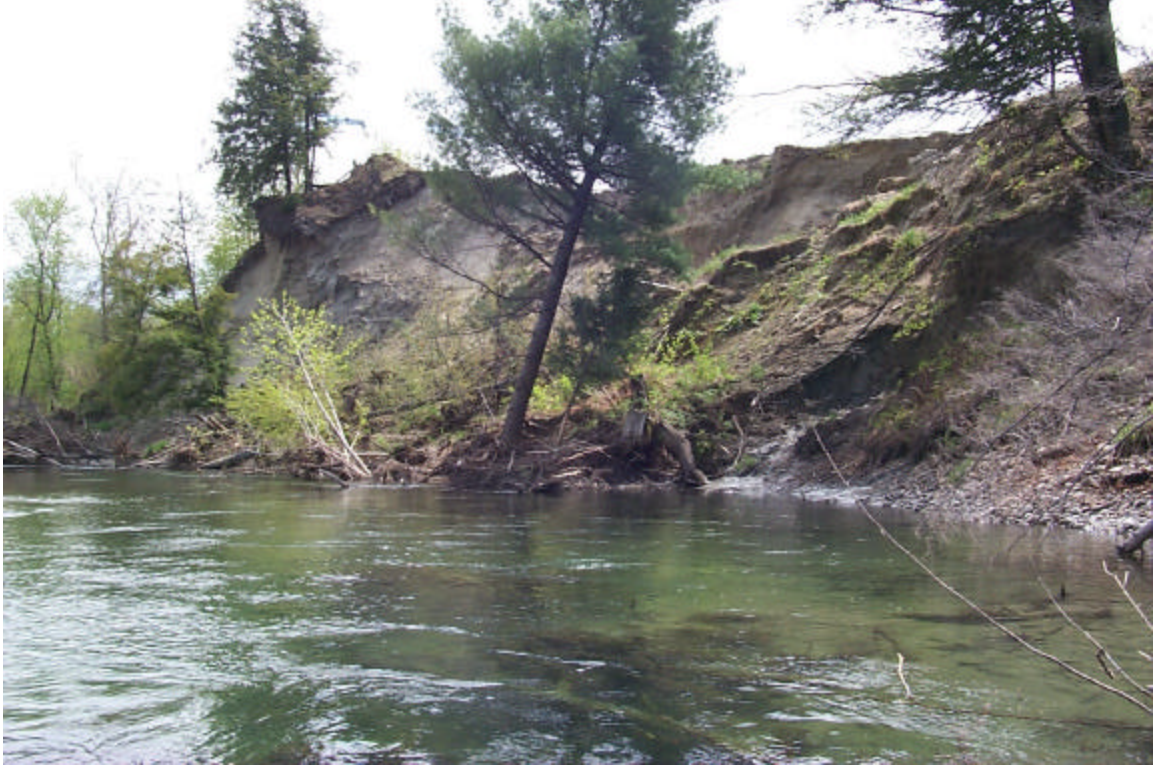
Figure A10

Third Branch, Randolph - Slope Failure (#26)

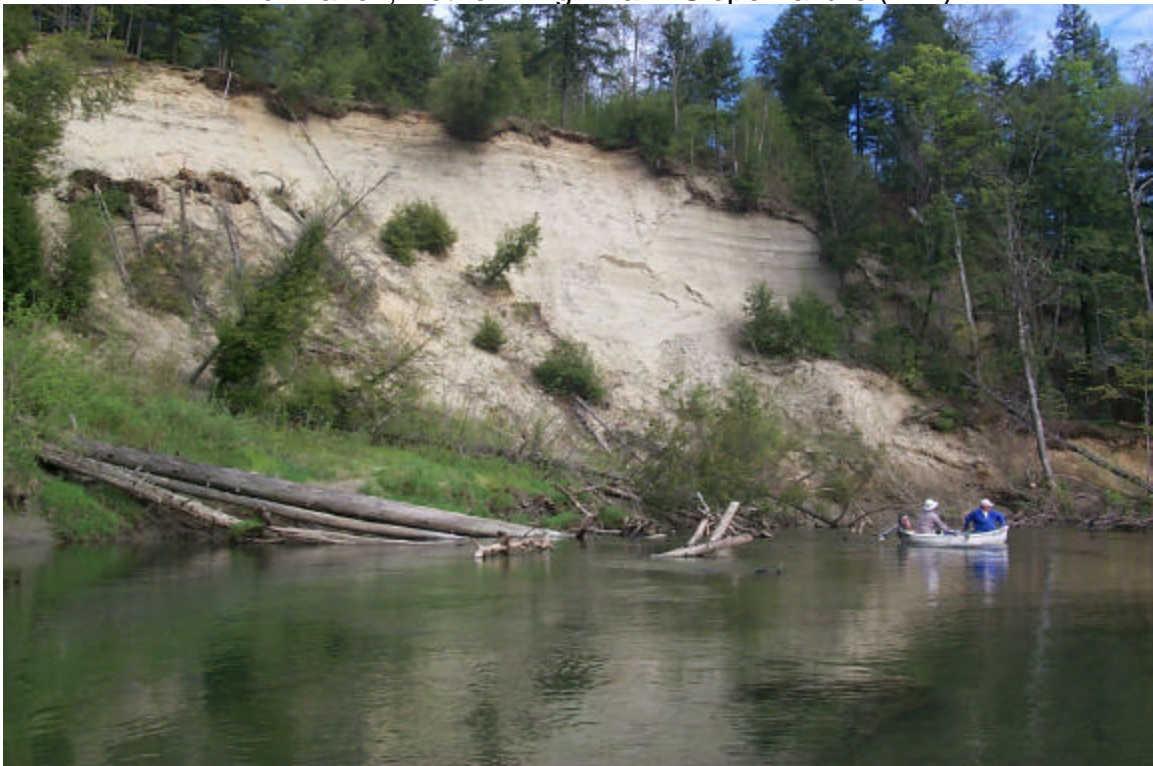
Figure A11

Third Branch, Bethel - High Bank Slope Failure (#42)

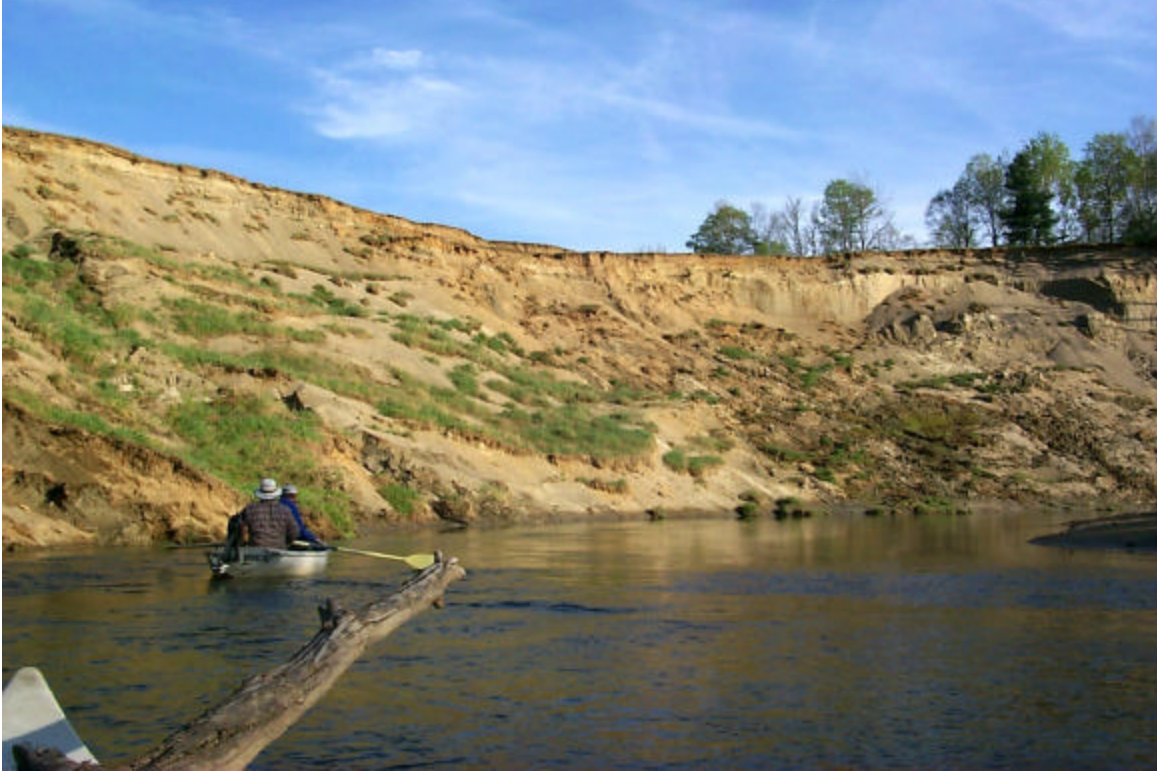
Figure A12

Third Branch, Bethel - Large Slope Erosion (#48)

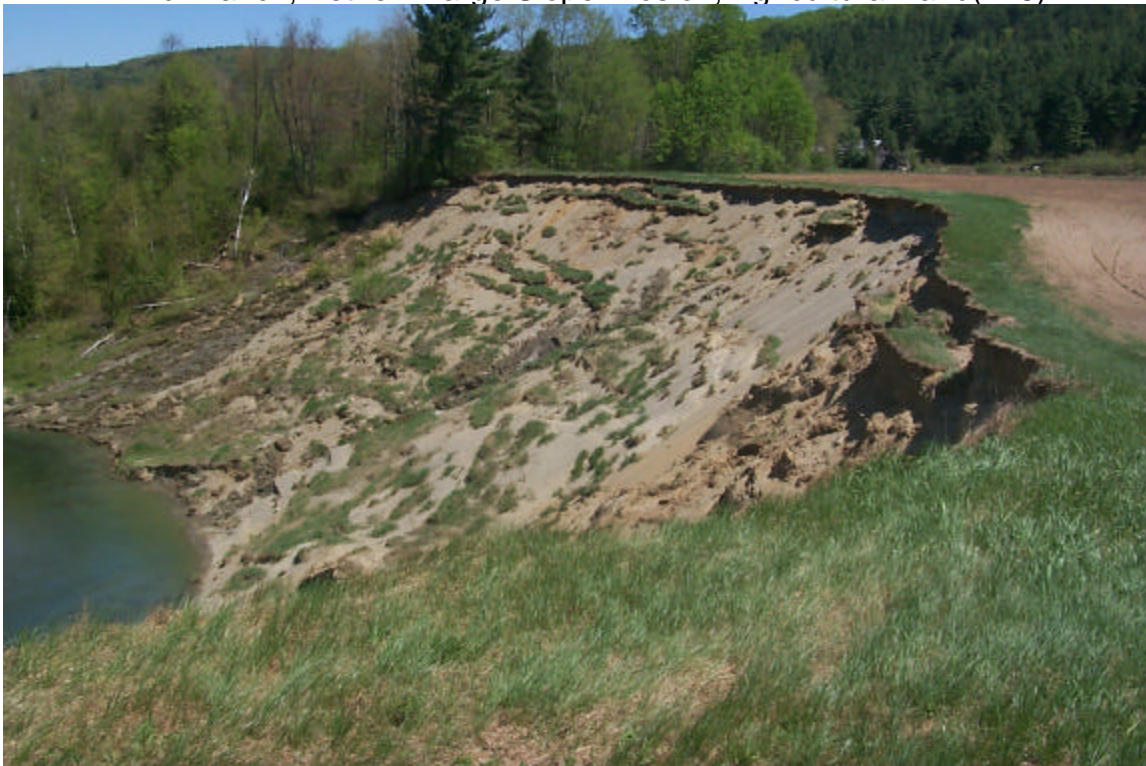
Figure A13

Third Branch, Bethel - Large Slope Erosion, Agricultural Land(#48)
